### *Detection of cavities under concrete pavement*

# CRREL Report 83-18

July 1983

Austin Kovacs and Rexford M. Morey

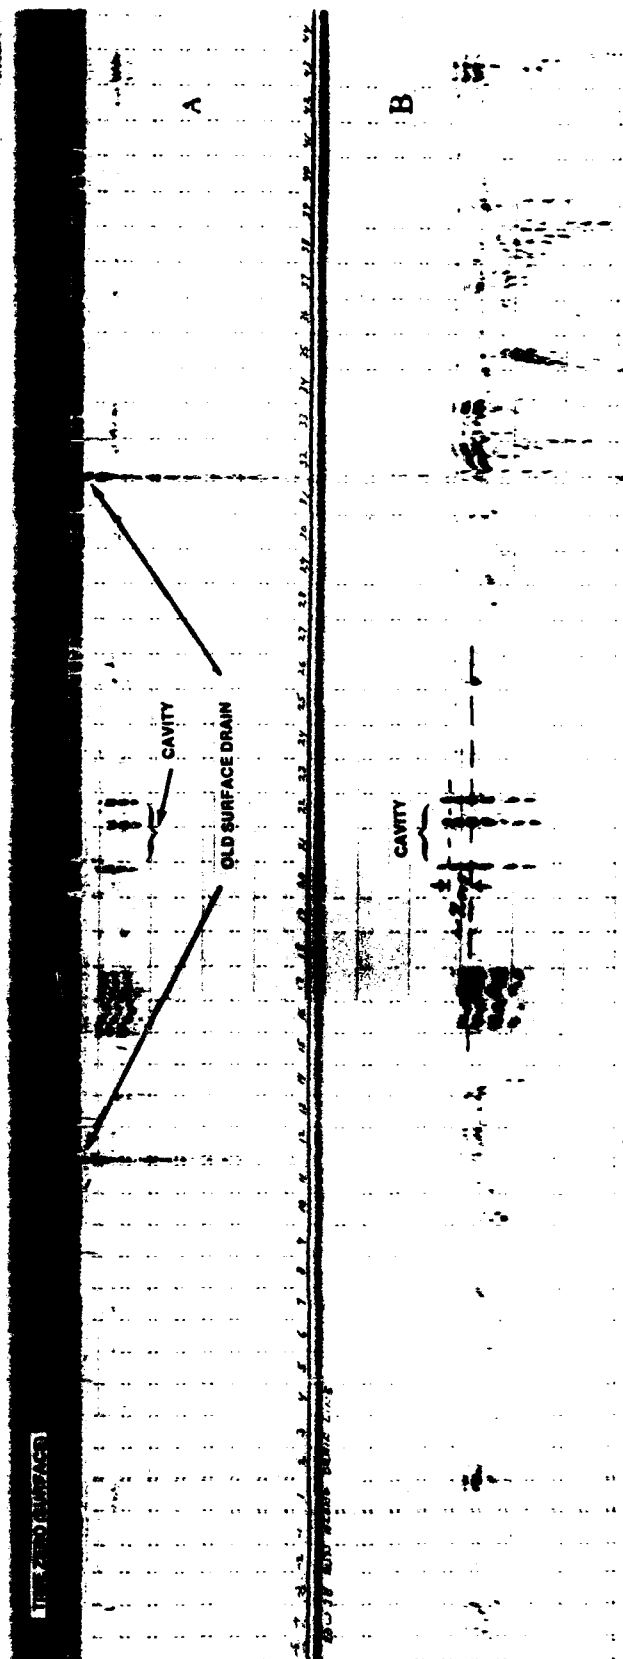
Figure 22. Portion of radar profile on row 3B from slab 5 to slab 44 over a 30-in. drain line. The scale lines are 5 ns apart.

A radar profile along the 30-in. drain line on row 3B is shown in Figure 22. On this run, three cavities were detected, one under slab 20 and two under slab 22. The strong return seen in trace A at the location of the old surface drains is due to the metal catch-basin grates. These grates reflect the EM energy back to the antenna and cause the "ringing" depicted by the dark banding.

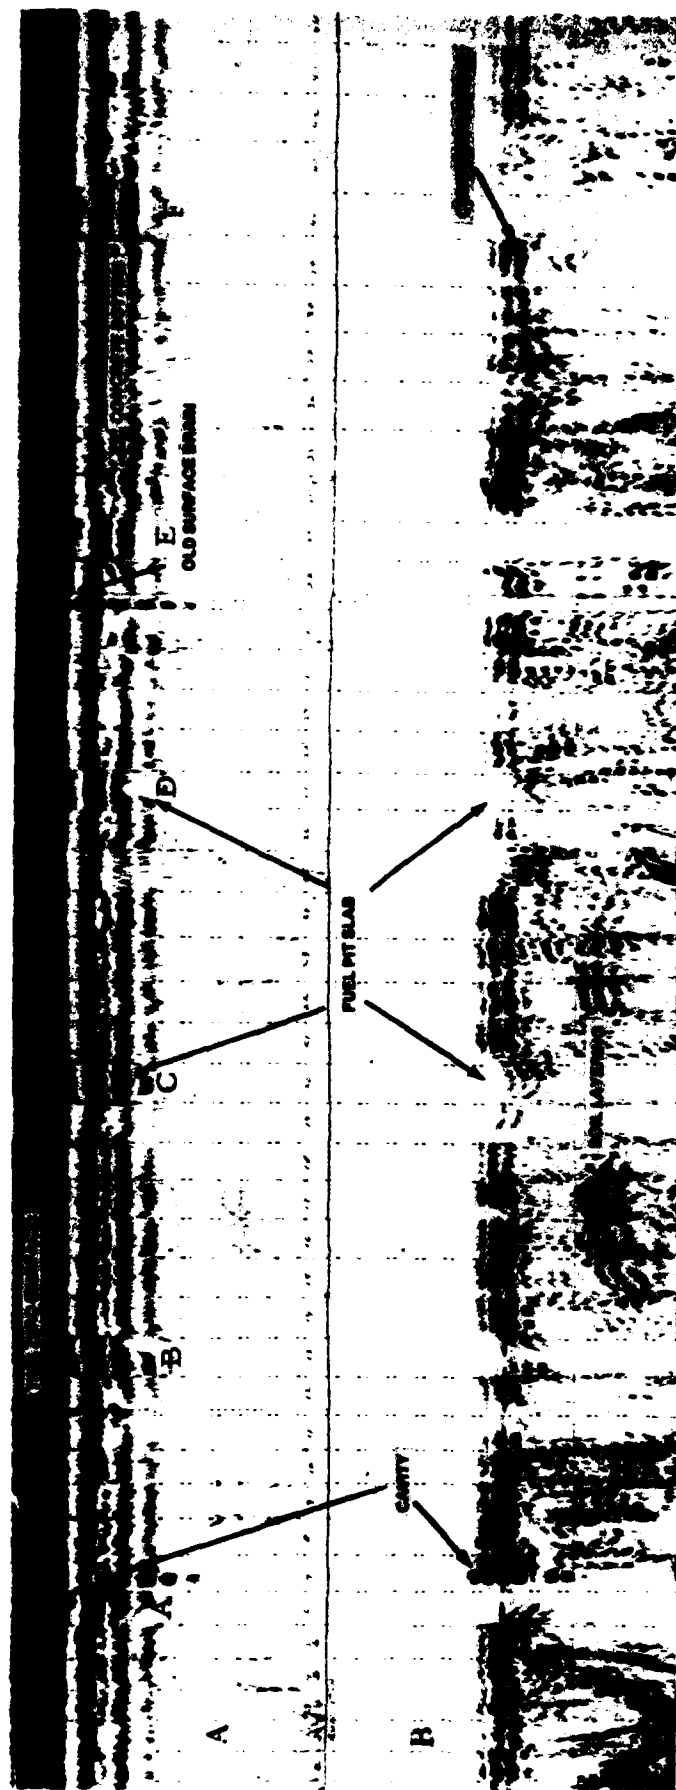
The radar profile along fuel pit row 17A is shown in Figure 27. A cavity was detected under slab 7, the site of which is shown in Figure 28. The odd shape of this cavity, determined from the radar mapping procedure previously discussed, is shown in Figure 29. To verify this shape, two 6-in.-diameter holes were cored through the slab, one at the outer edge and one near the center. The core hole at the outer edge broke through the pavement exactly on the lip of the cavity. Into this hole was lowered an electric light, and a viewing mirror was lowered through the center hole. Visual inspection of the cavity was thus possible, and this verified that the shape of the cavity was as mapped out on the surface. The slab thickness was measured to be 14 in., and the cavity was found to be 9 in. deep. The unique feature of this cavity was that it had quite steep sides and the floor was a flat concrete surface on which there were a few small pebbles and a dusting of sand. The concrete floor is the top of a fuel-line utility box that connects to fuel pit A on slab 6.

Figure 27. Radar profile on row 17A between slab 1 and slab 44. The scale lines are 10 ns apart.
